National Register of Historic Places Registration Form

historic name Belvedere Apartments

street & number 29 South State Street

city or town Salt Lake City

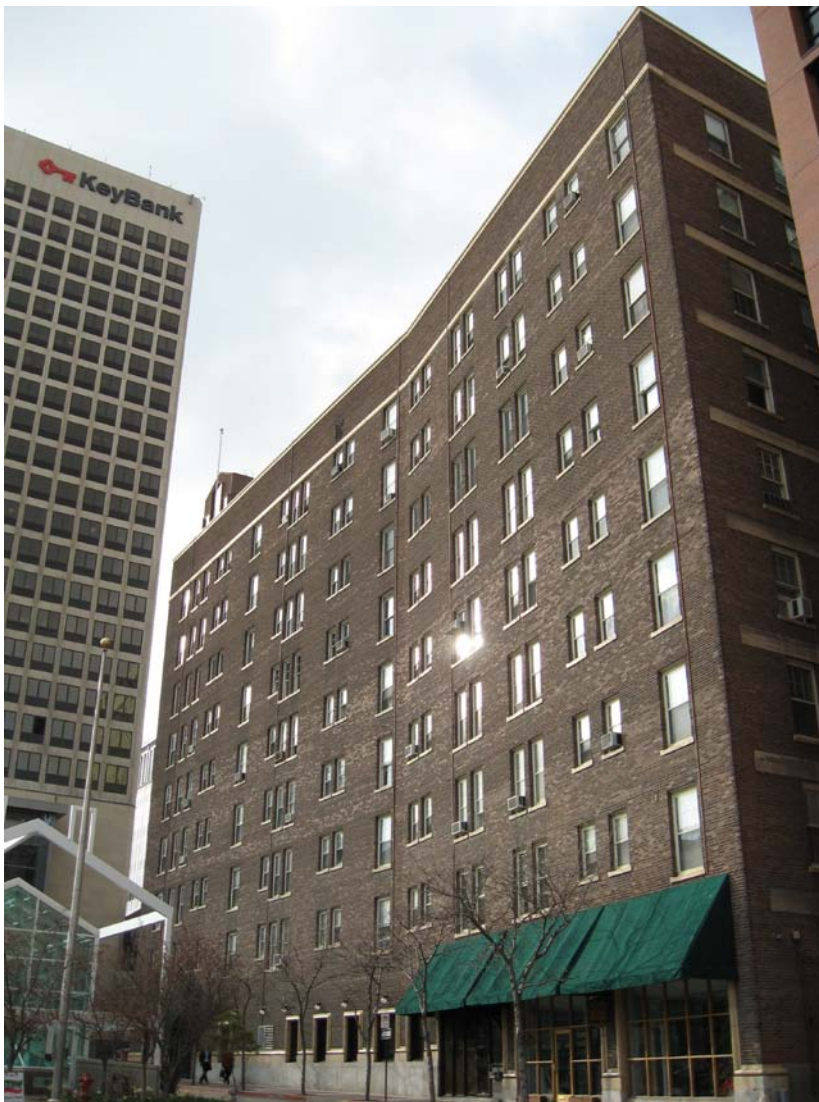
2 of 5

South and partial east façade

6 of 12. South and partial east facades. Camera facing northwest.

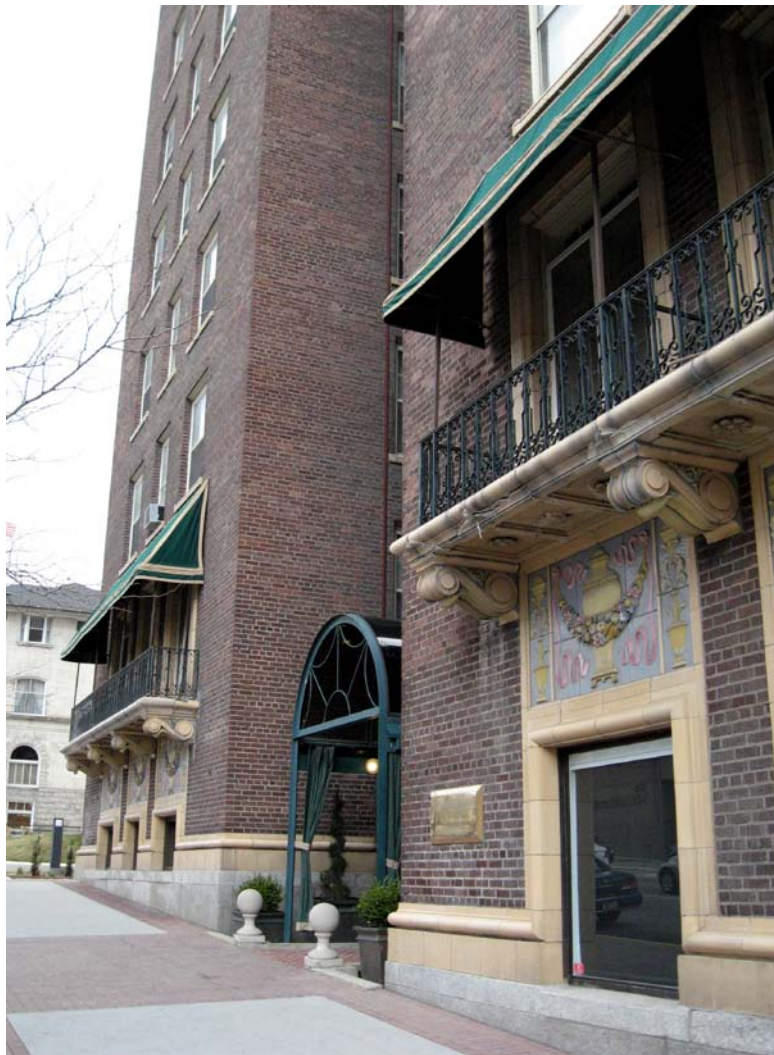
3 of 5

Detail of front (west) façade.

4 of 12. Detail of west façade. Camera facing northeast.

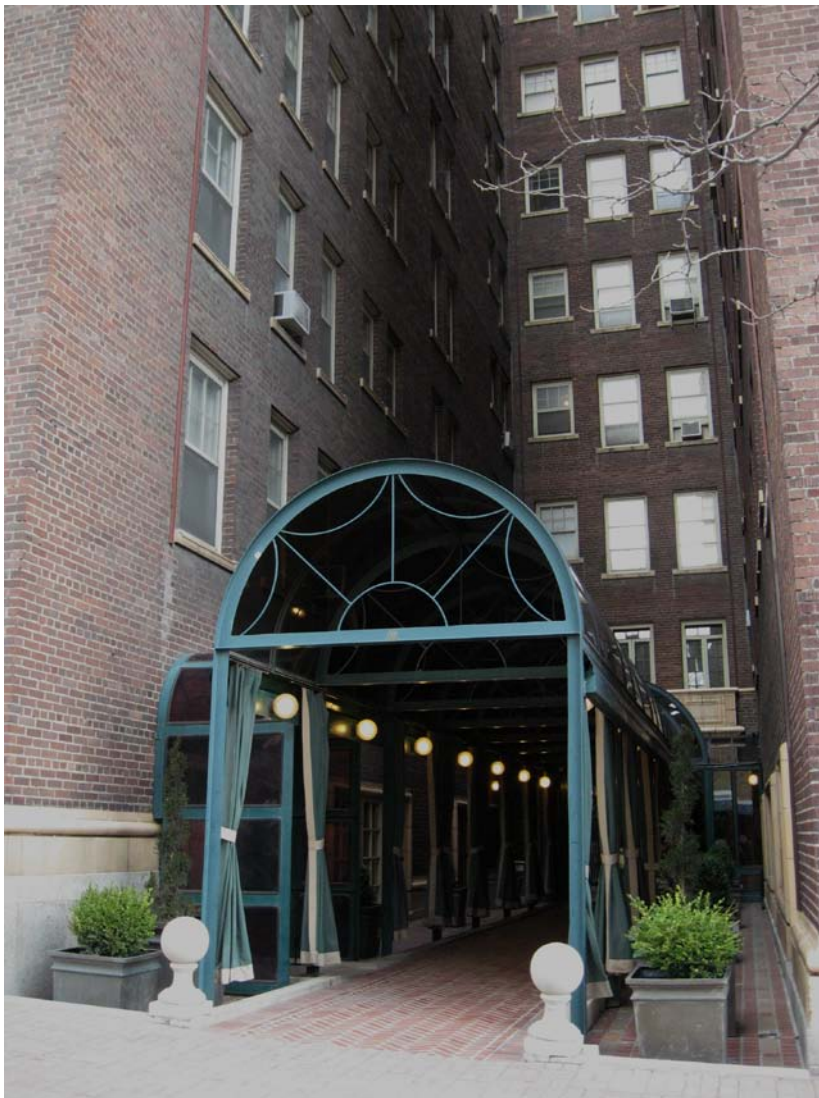
4 of 5

Detail of entrance, west facade

footprint contains mechanical rooms, building support spaces and portions of the commercial spaces (now offices) that front onto Social Hall Avenue. At the entry courtyard, the ground level treatment of masonry detailing extends with terra cotta, brick masonry and tile pavers to the historic building entry, now enclosed by a c.1975 steel and glass entry vestibule for weather protection. The depth and narrowness of this courtyard and proximity of the masonry detailing and historic multi-light windows increases the historic character and experience of building entry. A steel frame, barrel vaulted canvas canopy extends from the State Street sidewalk to the building entry. While this is a newer feature, very early historic photos show two previous versions of this entry/weather protection feature; one gable-roofed and the earliest, a barrel-vaulted form that extended to the State Street curb.

5 of 12. Detail of entrance, west façade. Camera facing east.

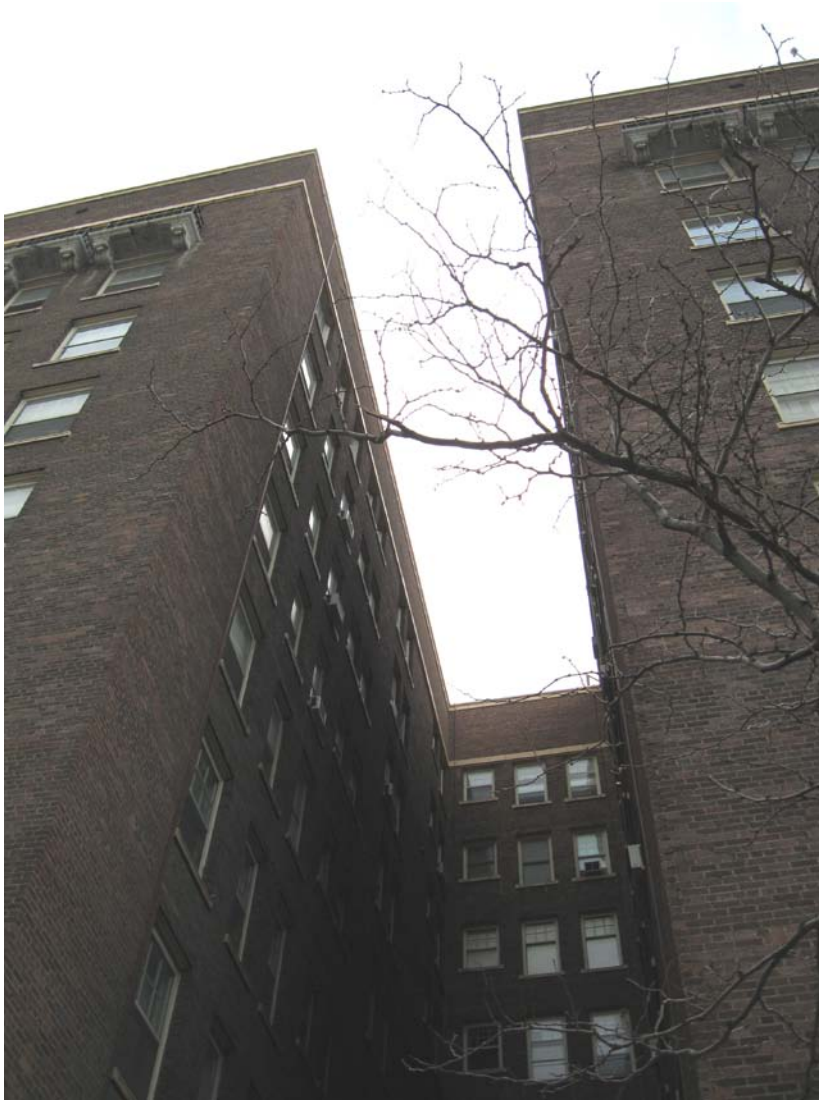
1 of 5

Detail of front façade, upper stories

The concrete frame building, originally advertised as "fire proof," is clad in a dark reddish-brown, almost purplish brick. Laid in a Common or American bond with regular header courses, the brick masonry forms a tight, planar skin to the building and is devoid of any decorative treatment. The half-height foundation cladding is cool gray granite, smooth ashlar with simple continuous profile as it transitions to the brick. At this juncture is the first use of decorative terra cotta, one course of tall, 'cubic' units followed by a continuous half-round molded water table band that encircles and frames the various window and door openings at the First Level. Because of the slope across the site, these windows decrease in height toward the north and appear nearly as basement windows at the northwest corner of the building. On the primary (west) elevation, on both the second and ninth levels, small projecting balconies break the tight plane of this elevation. The balconies are of cantilevered steel and concrete construction but have robustly detailed polychrome terra cotta scroll brackets and soffit cladding. Below the lower balconies are large panels of polychrome terra cotta depicting urns and vegetation. Decorative iron railings surround the balconies which are accessed by multi-light French doors, unique to these few west elevation units. All window openings, arranged in a rigorous layout repeated on each level, have simply-detailed terra cotta sills. A slightly projecting terra cotta band connects all Ninth Level openings in a continuous lintel or implied cornice line. A tall blank brick-clad 'attic' level above is terminated by a continuous terra cotta parapet cap with a slightly molded profile. The roof is low-slope and fully concealed by the full-perimeter parapet.

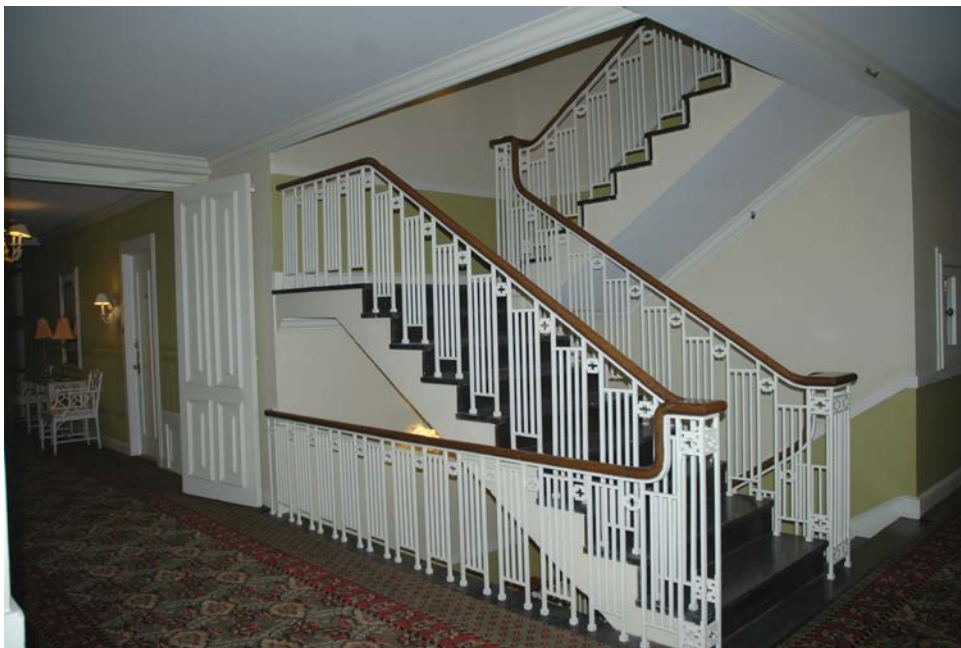
1 of 5

Interior detail, stairway ballustrade

After passing through the historic entry, the remodeled lobby provides connection to the pair of elevators with open wrought iron stairs flanking the H-plan 'crossbar'. These vertical circulation features continue to all upper floors and with the regular H-shaped hallway layout provide continuity throughout the building. The double-loaded corridors retain their historic character and configuration with the exception of all hallway ends, formerly terminating with exterior windows that have now been absorbed through modifications with adjacent apartments. The loss of historic termination and natural light is an impact to the corridors but remaining historic layout, historic doors, trim and other elements such as the short pass-through doors originally for setting out small dust bins from each apartment remain and the overall historic character of the original corridors is clearly evident.

7 of 12. Interior stairwell detail. Camera facing northwest.

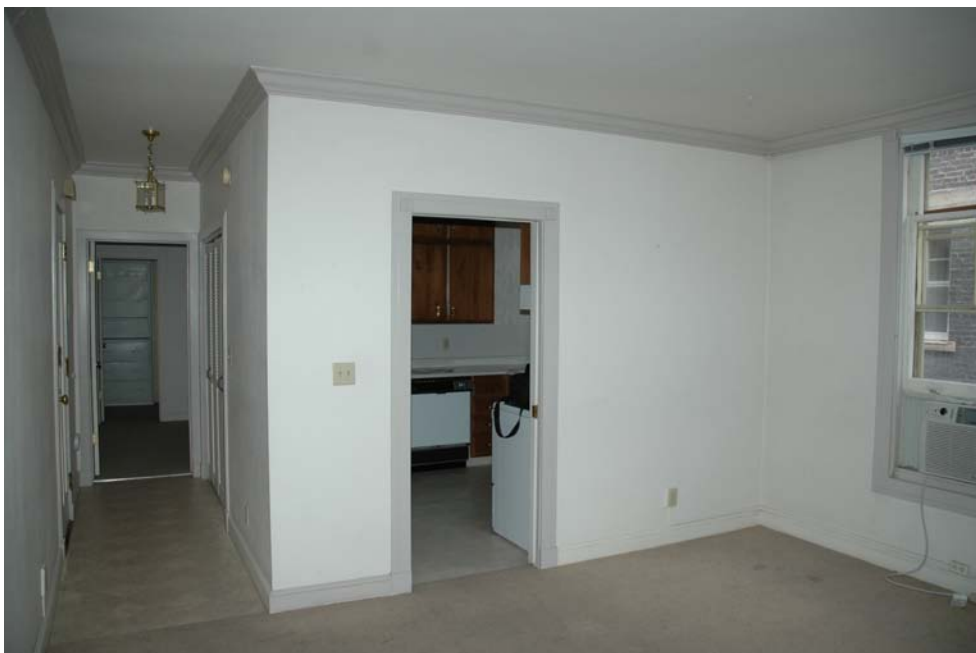
1 of 5

Interior detail, typical room layout

While apartment units at the ends of the corridors have expanded, most units retain their historic layout as well as detailing and features. Originally, on each level there were seven efficiency units, nine with a living room and either a dining or bedroom, and two units with three main rooms: living, dining and a single bedroom. (These larger units were located on the southwest corners of the front/west 'wings' perhaps to take advantage of sunlight, views or fairly prominent locations.) In all cases, the rooms are rather small, with the average unit area of about 506 sq. ft. All units had small "buffet" kitchens and bathrooms. In-building or in-unit features and services noted in the original advertising (copy attached) such as built-in dressers were apparently intended to compensate for the compact living space. The general lack of separate, dedicated bedrooms was originally addressed through the provision of folding 'Murphy' beds that were attached to a closet door making dining or living rooms dual purpose. (This arrangement was likely somewhat inconvenient particularly for older tenants and none of these beds remain although many 'efficiencies' do.) Reasonably well-equipped kitchens and "tiled" bathrooms are likely nearing the end of their typical functional life span and most have been updated or modified. Built in "dressing tables, drawers and shelves" have remained in many units.

9 of 12. Apartment detail. Camera facing northwest.

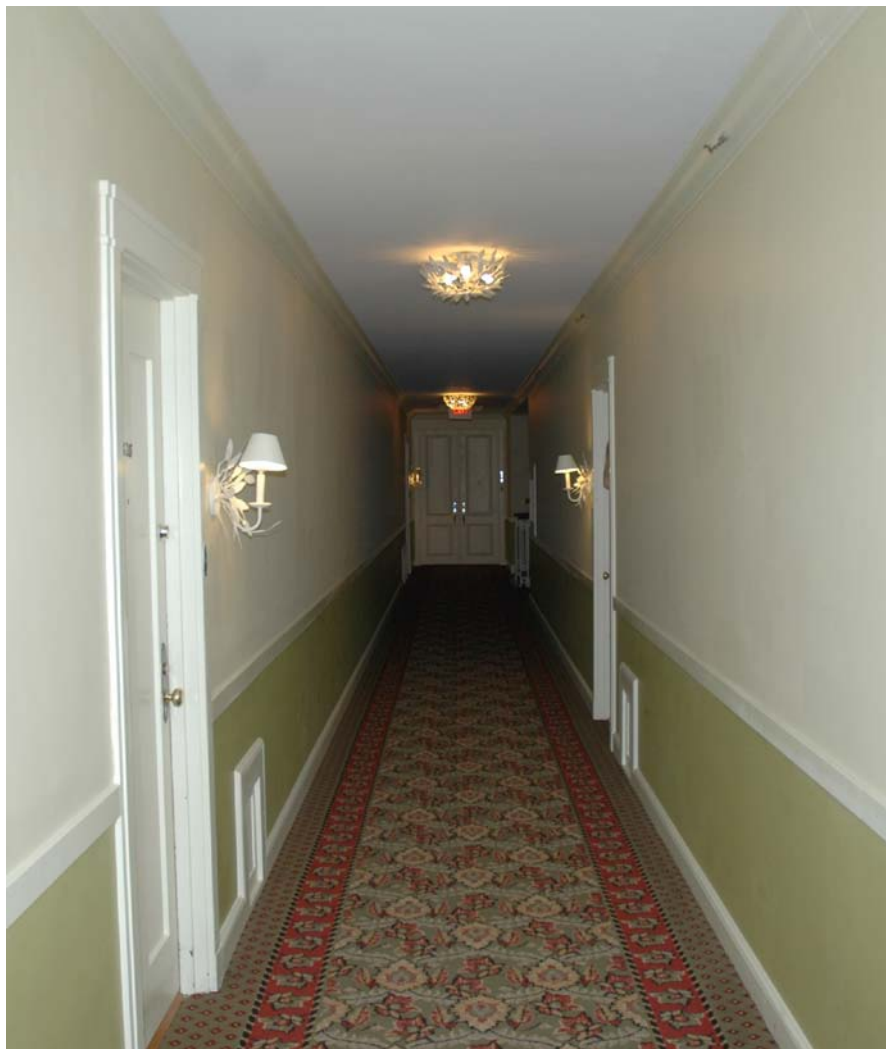
1 of 5

Interior detail, typical corridor

8 of 12. Interior hallway detail. Camera facing east/
